DEPARTMENT OF TRANSPORTATION

Quality Assurance and Source Inspection

Contract #: 04-0120F4Cty: SF/ALA Rte: 80 PM: 13.2/13.9File #: 69.28**WELDING INSPECTION REPORT****Resident Engineer:**Siegenthaler, Peter**Address:** 333 Burma Road**City:** Oakland, CA 94607**Report No:** WIR-019423**Date Inspected:** 21-Jan-2011**Project Name:** SAS Superstructure**OSM Arrival Time:** 700**Prime Contractor:** American Bridge/Fluor Enterprises, a JV**OSM Departure Time:** 1900**Contractor:** Zhenhua Port Machinery Company, Ltd (ZPMC), Changxing Island **Location:** Shanghai, China**CWI Name:** An Qing Xiang**CWI Present:** Yes No**Inspected CWI report:** Yes No N/A**Rod Oven in Use:** Yes No N/A**Electrode to specification:** Yes No N/A**Weld Procedures Followed:** Yes No N/A**Qualified Welders:** Yes No N/A**Verified Joint Fit-up:** Yes No N/A**Approved Drawings:** Yes No N/A**Approved WPS:** Yes No N/A**Delayed / Cancelled:** Yes No N/A**Bridge No:** 34-0006**Component:** OBG**Summary of Items Observed:**

BAY 14, OBG 13AW (NWIT # 08254)

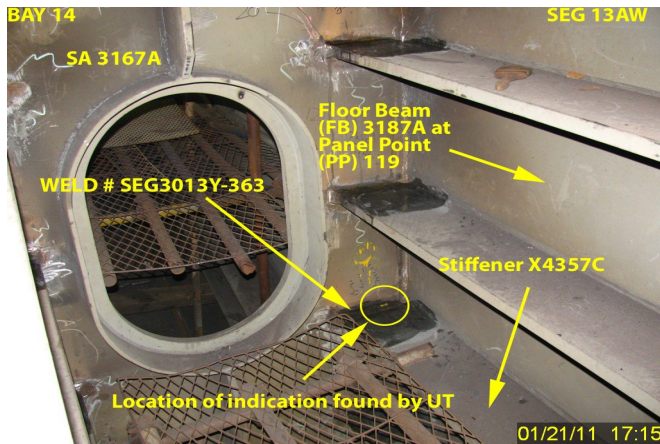
SEG3013Y-363 (One class "A" UT rejectable indication found)

- The depth of the indication is 27mm from face A.
- The db rating is +5.
- The material thickness is 35mm.
- The weld is identified as: SEG3013Y-363.
- The Weld is a Complete Joint Penetration (CJP), Tee-joint, joining the stiffener X4357C of Floor Beam (FB) 3187A to the Sub Assembly (SA) plate SA3167A at Panel point (PP) 119.
- The “Y” location of the indication is 155mm from the free edge of the stiffener (as shown in attached photograph).

- The indication is clearly marked on the component.
- The material is identified as Seismic Performance Critical Member (SPCM).
- The member is located in Bay 14.

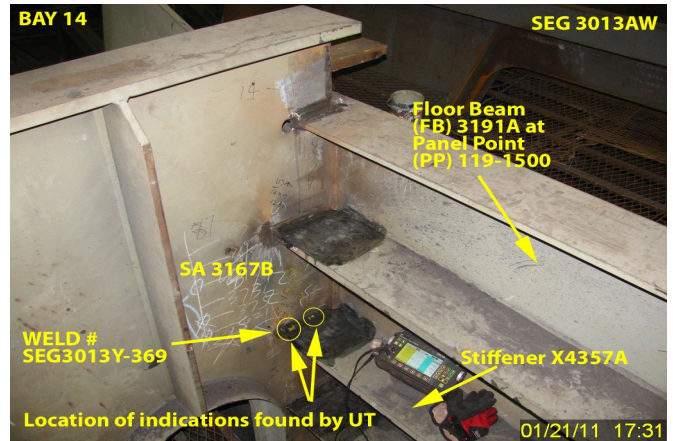
SEG3013Y-369 (Two class "A" UT rejectable indications found)

- Two class “A” longitudinal indications measuring approximately 20mm and 22mm in length respectively.
- The depth of the indications is 30mm and 31mm respectively from face A.
- The db rating is +7 for each.
- The material thickness is 35mm.
- The weld is identified as: SEG3013Y-369.
- The Weld is a Complete Joint Penetration (CJP), Tee-joint, joining the stiffener X4357A of Floor Beam (FB) 3191A to the Sub Assembly (SA) plate SA3167B at Panel point (PP) 119-1500.
- The “Y” location of the indications is 20mm and 120mm respectively from the free edge of the stiffener (as shown in attached photograph).
- The indication is clearly marked on the component.
- The material is identified as Seismic Performance Critical Member (SPCM).
- The member is located in Bay 14.

The Notice of Witness Inspection Number (NWIT) is 08254. The indication is located inside the area that has been previously tested and accepted by ZPMC Quality Control (QC) personnel. As per the contract documents, ZPMC’s QC personnel are required to perform 100% UT inspection of these welds. Attached photographs provide additional location details.

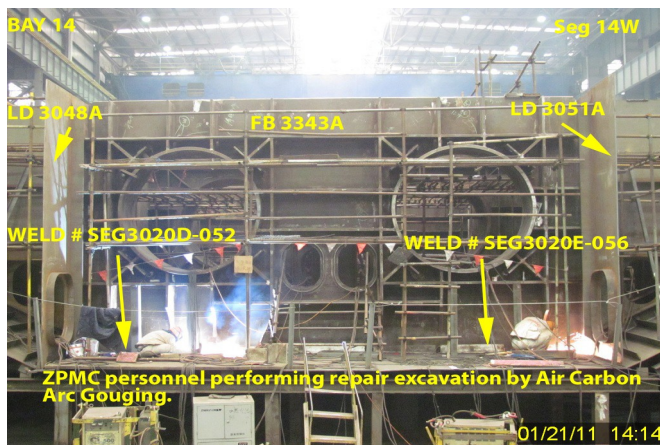
During random in process inspection this QA inspector observed that ZPMC personnel were performing Air Carbon Arc Gouging for the excavation of repair. The weld joints are identified as SEG3020D-052 joining FB 3343A to BP 3091A/3092A and SEG3020E-056 joining FB3343A to BP 3092A/3093A. These weld joints are Ultrasonically rejected by ZPMC NDT personnel. Attached photograph provide additional details.
